Servicing of Hydraulic Elevators after Flooding

What to look for and keep in mind when attending hydraulic elevators after water damage

by Parag Mehta

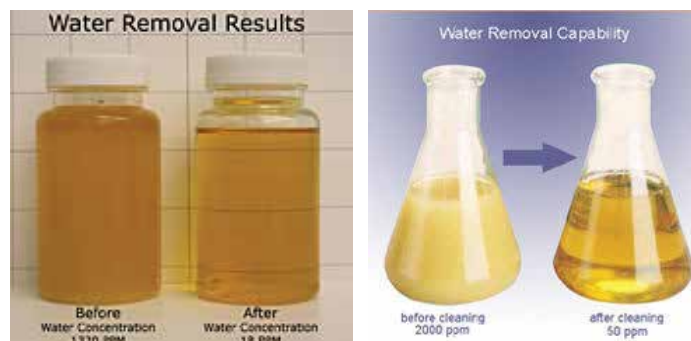
Figure 1: Comparisons of hydraulic oil mixed with water

the most widely used international standard for representing oil contamination. In normal cases, oil is decontaminated using onsite portable oil filtration units without causing any major downtime. However, this only helps when water has not mixed with oil and oil composition has not changed. Floodwater brings lots of sludge, waste and fine particles, which get mixed with the hydraulic oil if the tank is submerged. Once contaminated, the hydraulic oil is more or less unusable, as using a specialized process of separating the water from the oil would not be commercially viable considering the amount of oil the tank holds.

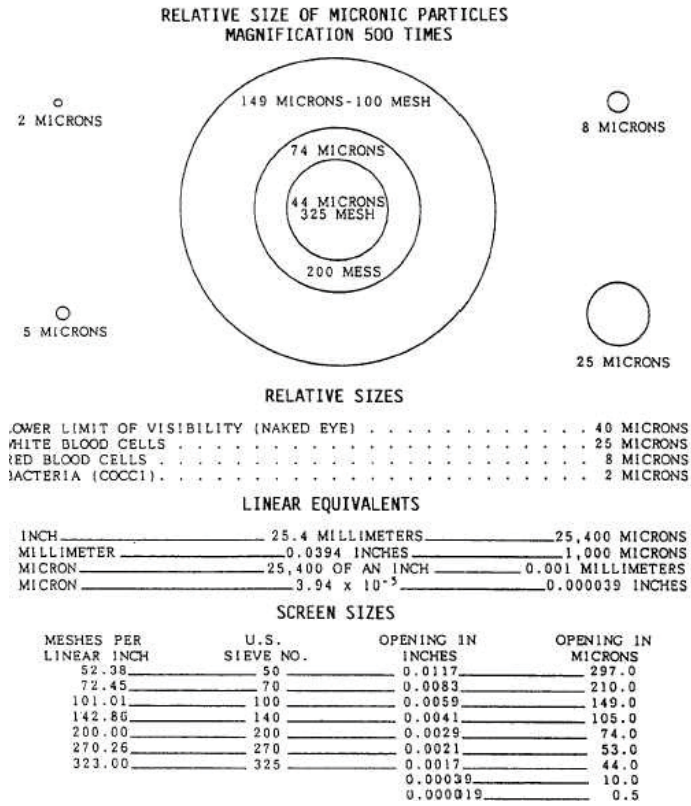
Figure 2: Contamination particle sizes reference

Impurities present in contaminated oil are not always visible to the human eye. A human hair visible to an eye has an approximate diameter of 75 µm. Fine contamination present in hydraulic oil ranges from 5-15 µm, whereas, generally, a human eye cannot see particles smaller than 50 µm.

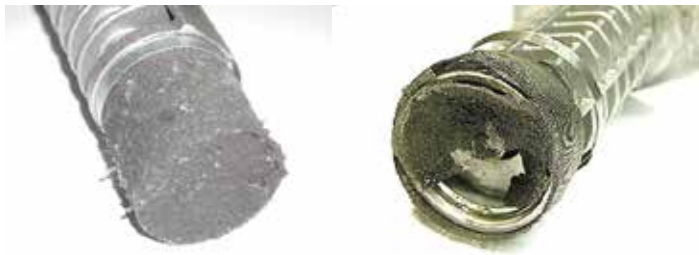
Figure 3: Clogging of pump filters

Apart from particle-based contamination, sludge carried by flooded water may get deposited in the tank and eventually be sucked out by the pump. This sticky material, together with contamination, may not only block the filter of the pump (which can create negative pressure if not cleaned properly), but also cause damage to the finely machined screws of the screw pump. Over time, the filter and fixing clip might even break or jam due to oxidation.

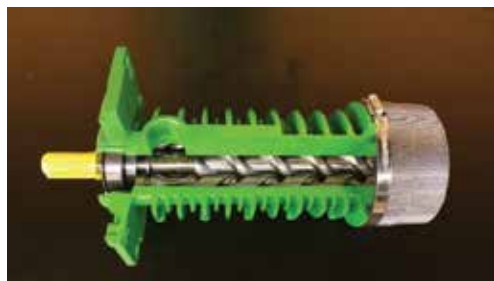
Figure 4: Section view of a submersible screw pump

As submersible screw pumps are designed to operate in oil, the material used for screws can rapidly oxidize once it comes in contact with water. The screws (two idlers and one rotor) are grinded to a fine finish and manufactured with tight tolerances.

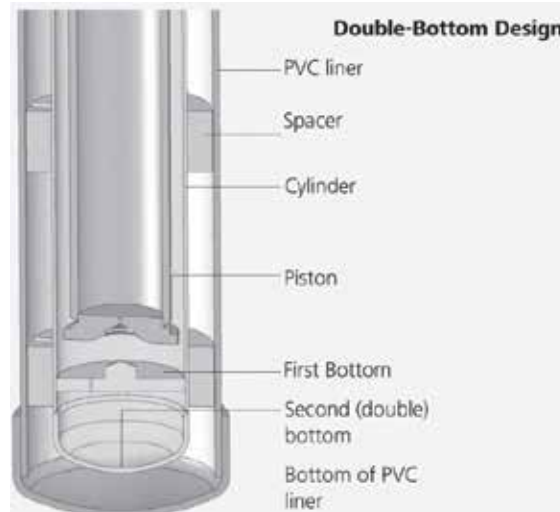
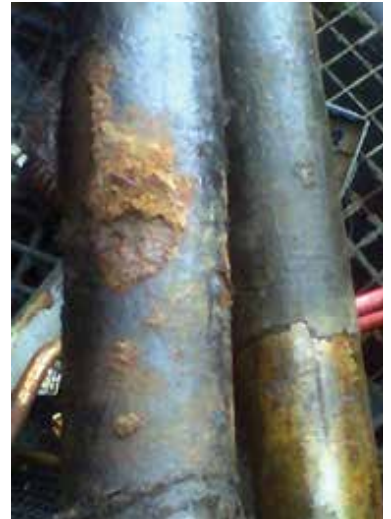
Figure 5: Double-bottom hole-type cylinder in PVC sleeve to prevent ground moisture from coming in contact with cylinder (picture source: Schindler and Delta Elevator Co. Ltd.)

As can be seen in Figure 5, a buried (hole-type) cylinder has a double-bottom base. The cylinder is enclosed inside a PVC tube, which is distanced from the PVC liner with spacers. The double-bottom base (with a PVC bottom layer) provides the extra protection layer against ground-based moisture and prevents rusting.

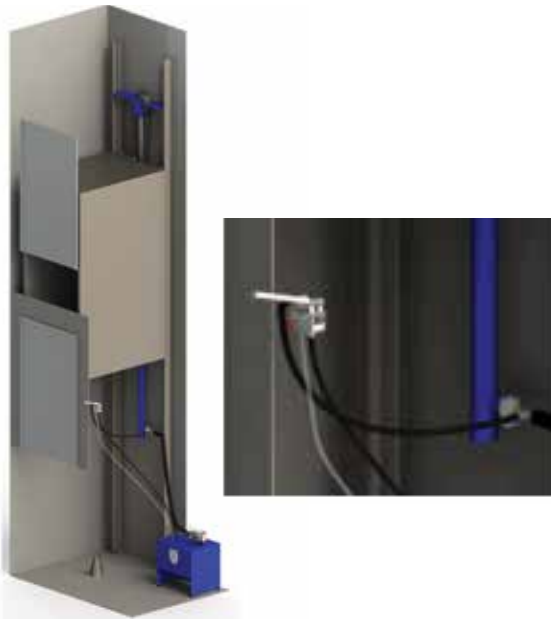
Figure 6: Emergency rescue using an MRL-H rescue unit

- 1) Place the power unit on the first floor in areas more likely to be flooded.
- 2) In the case of an MRL installation or power unit located away from the access area, an MRL-H rescue unit should be used. This small unit acts like a remote control for performing rescue operations. It can be positioned beside the landing door for easy access. Emergency rescue operations like manually lowering the cabin, pumping the cabin up in case of flooding, closing the hydraulic line, etc. can be easily performed without accessing the machine room or power unit where the valve is located.
